Property Visit

Client name, office location	Online Estate Agents Ltd
Property Address (incl. postcode)	34 King John Street, hampshire, GU51 1HX
Property Type	3 bedroom Unfurnished House
Tenancy Length	
Tenant 1	Luke Clark
Tenant 2	Maya Tsigankova
Clerk	D Gould
Date	09/10/2020

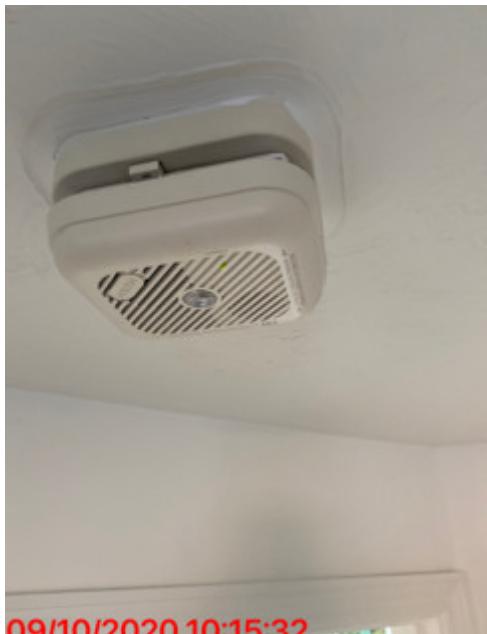
Smoke alarm in landing

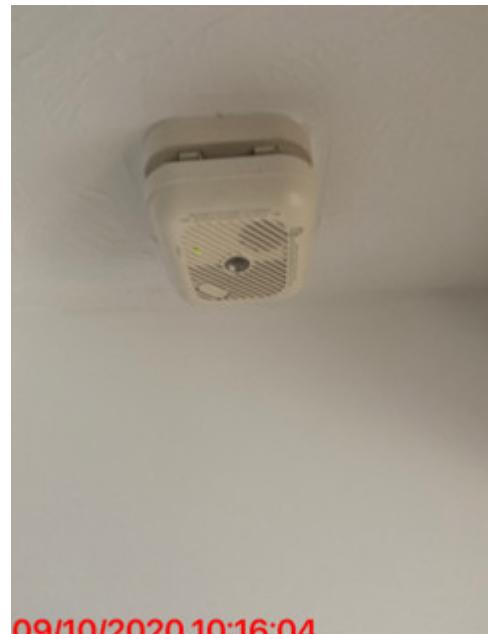
Smoke alarm at bottom of stairs

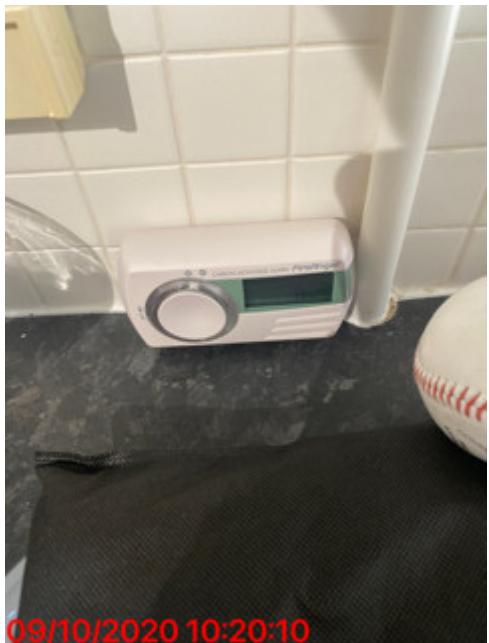
09/10/2020 10:20:10
Kitchen carbon monoxide alarm
